I. Introduction

II. Sidewalk Rating System for Pedestrians

III. Roadway Condition Rating System for Bicycles

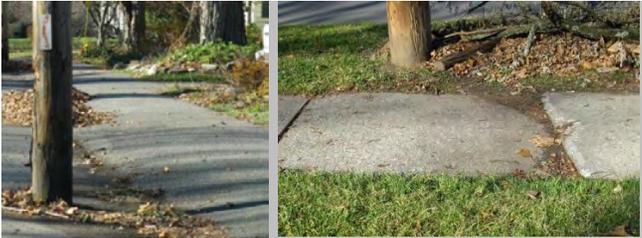
8 Excellent	Less than 1/8" vertical edge; little or no depressed or raised areas, for cement concrete cracked squares (no more than 2 pieces), no spalling of concrete surface or raveling of bituminous surface, no horizontal separation, or debris/vegetation

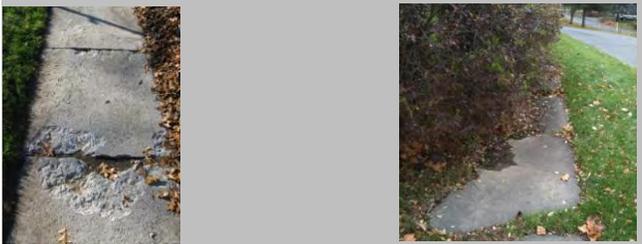
7 Good	Same as 6, but in slightly better condition. Needs routine maintenance – spot patch repairs/crack filling.

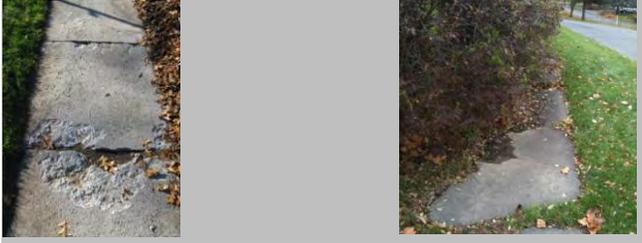
6 Good	Vertical edge between 1/8" and 1/4"; 0-1" raised/depressed; no more 3 cracked squares of cement concrete; less than 25% spalled concrete surface or bituminous surface, less than an inch of horizontal separation; less than 25% covered by debris/vegetation

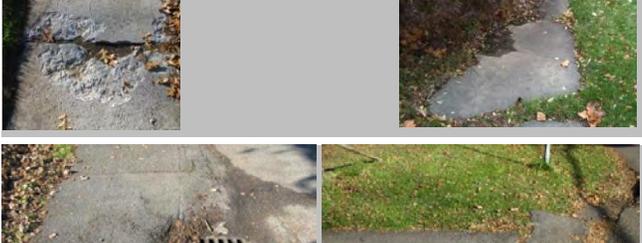
5 Fair	Same as 4, but in slightly better condition. Needs preservative fractural sealcoat/joint grinding.

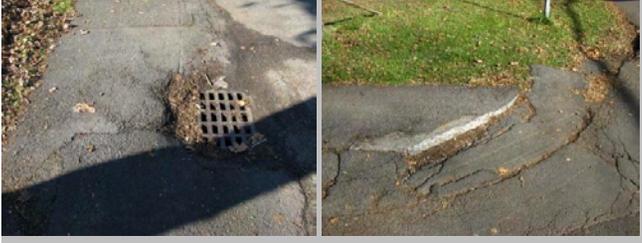
4 Fair	Vertical edge between 1/4" and 1/2" 1-2" raised/depressed; no more than 4 cracked squares of cement concrete; 25-50% spalled concrete surface or raveled bituminous surface; less 1-1 1/2" of horizontal separation; 25-50% covered by debris/vegetation

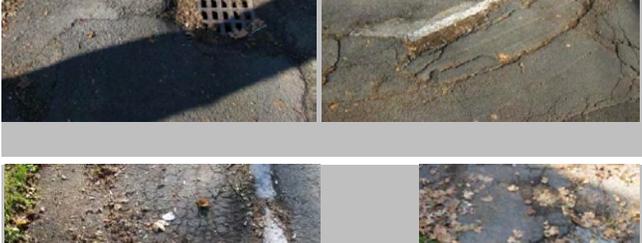
3 Poor	Same as 2, but in slightly better condition. Needs milling and/or structural overlay/patching or replacement of sections full width

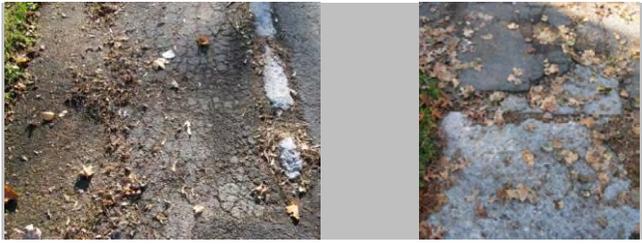
2 Poor	Significant aging. Vertical edge between 1/2" and 3/4"; 2-3" raised/depressed; no more than 5 cracked squares of cement concrete; 50-75% spalled concrete surface or bituminous surface; less 1 1/2-2" of horizontal separation; 50-75% covered by debris/vegetation

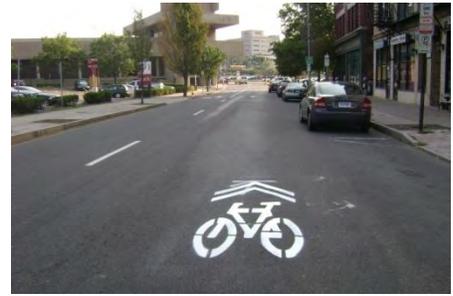
The criteria for pavement marking integrity (bike lane symbols, shared lane markings—aka sharrows), like stripe integrity, are also related to visibility (an example of a new shared lane marking is shown in photograph). Pavement marking integrity is often variable along the extent of a segment. The rating is usually based on the average integrity of pavement markings in the segment.

Pavement markings that have a visible integrity score of two or less need to be re-stripped.

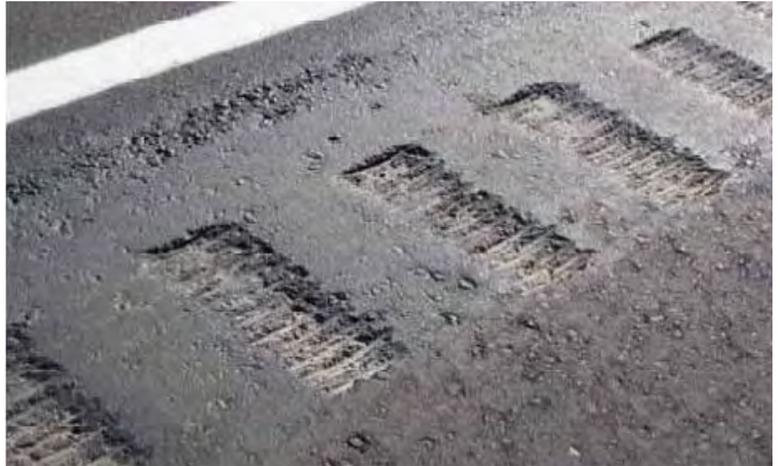
Rumble strips are virtually impossible to ride a bicycle on or over. They are at best uncomfortable, even for very short distances, and at worst can cause a cyclist to lose control of their bike and fall. They can damage a bicycle wheel, can cause a flat tire, and/or shake loose parts off a bicycle. Consequently, cyclists will avoid riding over them -- and when rumble strips leave no room on a shoulder, the cyclist will have no other option than to ride in the travel lane. (Source: League of American Bicyclists) If rumble strips are installed, the configuration, depth and spacing should conform to bicycle friendly designs developed by the Arizona DOT, Colorado DOT or the Delaware DOT.

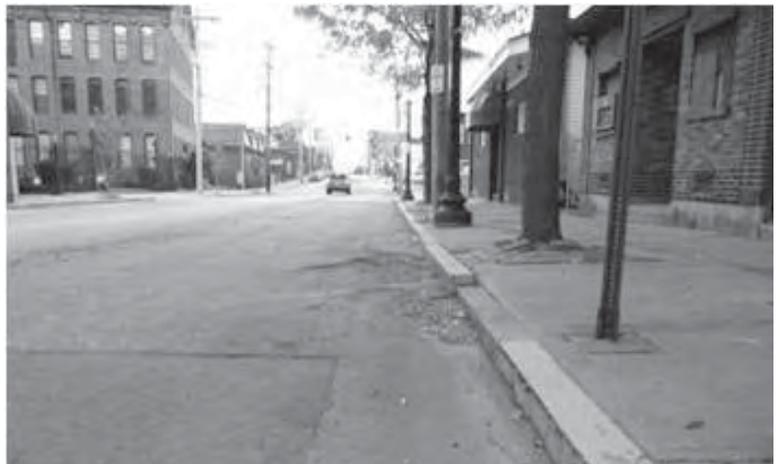
Pavement heaves due to tree roots can cause cyclist to fall or suddenly divert out into vehicle travel lane.

- Heaves <math>< 1/2\text{''}</math> -- rating good (7)
- Heaves $1/2\text{''}$ -- rating fair (5)
- Heaves 1'' to 2'' -- rating poor (3)
- Heaves $> 2\text{''}$ -- rating failed (1)

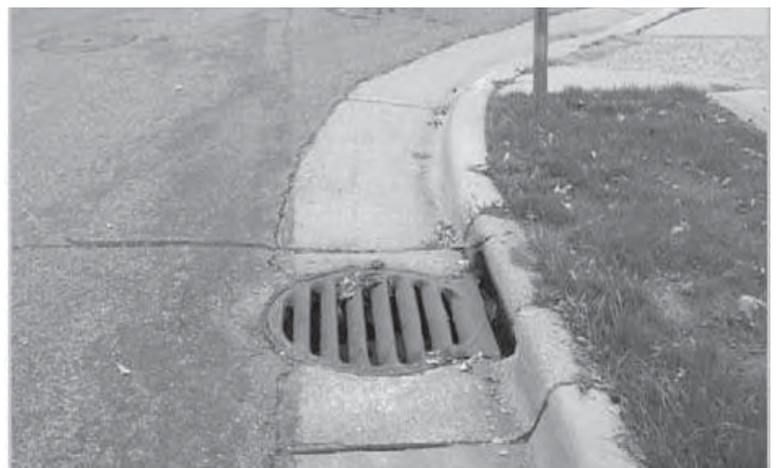
Bicycle Safe Drainage Grates: Storm grates pose a hazard for bicyclists when the openings are parallel to the bicyclists' direction of travel. Bicycle tires can get caught between the bars of these grates and cause bicyclists to fall. Unsafe drainage grates should be replaced with grates that are designed for bicycles.

- Unsafe grate -- rating very poor (2)

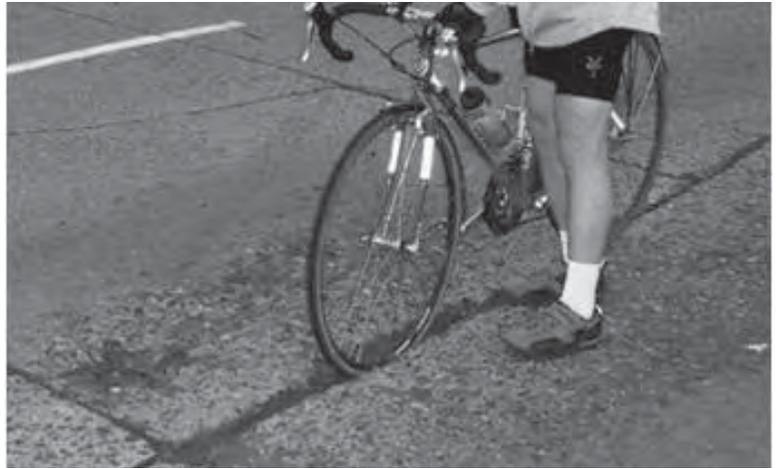
Wide longitudinal cracks can trap a bicycle wheel and cause sudden and severe fall.

- Cracks open 1/2" -- rating fair (5)
- Cracks open 1/2" to 1" -- rating poor (3)
- Cracks open >1" -- rating very poor (2)

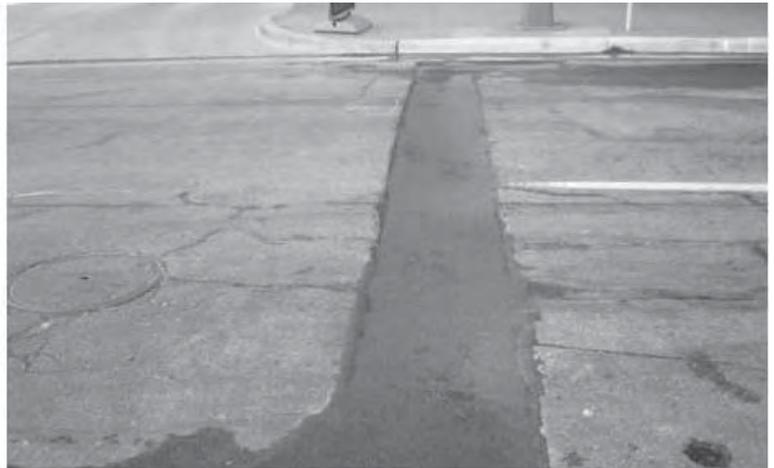
Large transverse cracks can create an uneven surface causing cyclists to lose control and fall.

- Follow general PASER rating system

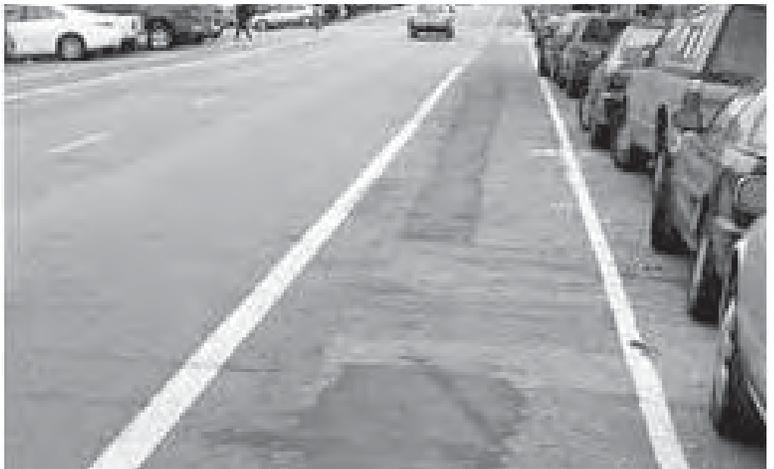
Uneven utility patches in bike lane or anticipated bicycle travel path can cause cyclists to divert out into traffic flow or lose control and fall.

- Follow general PASER rating system

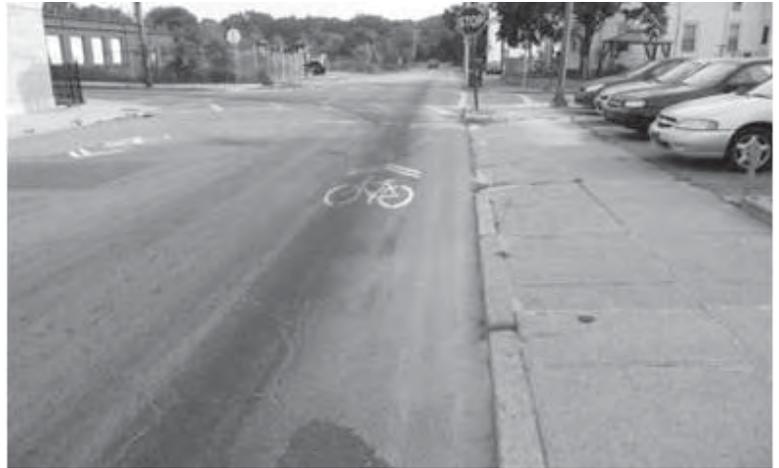
Faded sharrows or lane markings in bike lanes or in an anticipated bicycle travel path may not be visible in poor weather conditions or at night.

- Barely discernable or not visible -- rating poor (1)
- Visible with considerable wear -- rating fair (4)
- Visible with some wear -- rating good (6)
- Visible new or minimal wear -- rating very good (8)
- Visible like new -- rating excellent (10)

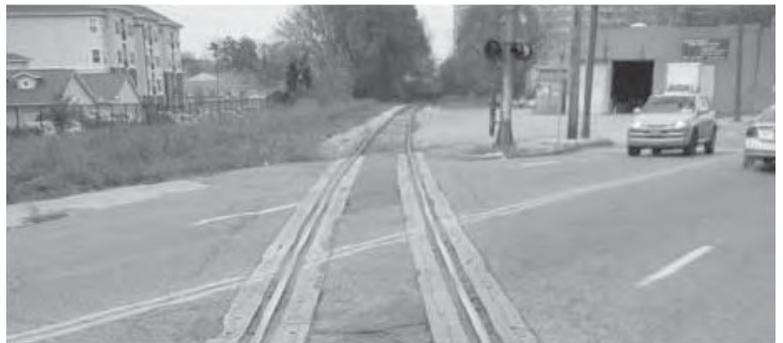
Railroad Crossings: Under certain circumstances, railroad tracks crossing the road can present a dangerous condition for bicyclists. At diagonal at-grade crossings, the gap next to the rail can trap the front wheel of a bicycle causing the bicyclist to fall. To prevent this from happening, the bicycle lane or shoulder should be designed to enable the bicyclist to approach the track at an angle closer to 90 degrees (but not less than 60 degrees) without having to swerve into motor vehicle travel lanes. The width and the dimensions of the widened area discussed above will be dependent upon the skew of the railroad tracks relative to the bicyclist crossing point. It is important that the bicyclist is given sufficient space on the approach and the departure of the crossing to safely transition back to the travel way.

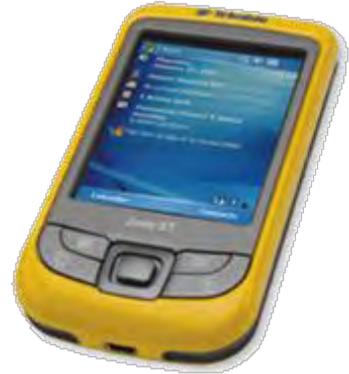
The Town of Bethlehem's Highway Department currently uses a Trimble brand hand held global positioning system (GPS) receiver/data collector for field reviews and evaluations of roadway pavements to accommodate motor vehicle travel. The Trimble Juno™ ST provides 2 to 5 meter GPS positioning in real time. ESRI's ArcPad version 7.0, installed on the Trimble Juno™ ST, is utilized as the GIS program during mobile field data collection. The Trimble Juno™ ST includes a "Pavement.mxd" workspace, loaded onto the device by the Town's GIS Coordinator. The only layer in the workspace is a roadway "Streets.shp" shapefile, which includes the following attribute fields – Street Name, Rating, Date, and Length. Current Town practice is for the Highway Department staff to select the roadway being evaluated and enter the pavement condition rating (0 – 10 scale) into the attribute field. Once the year's roadway pavement evaluation is completed by the Highway Department, the Town GIS Coordinator uploads the evaluation rating data ("Streets.shp" shapefile) to the Town's GIS database and prepares a color coded map based on the pavement ratings (i.e. Green – good condition, Red – poor condition). The GIS Coordinator also conducts post processing of the data based on the observations and notes prepared by the Highway Department staff who conducted the evaluation. The Highway Superintendent utilizes the roadway pavement evaluation as the basis for roadway resurfacing projects.

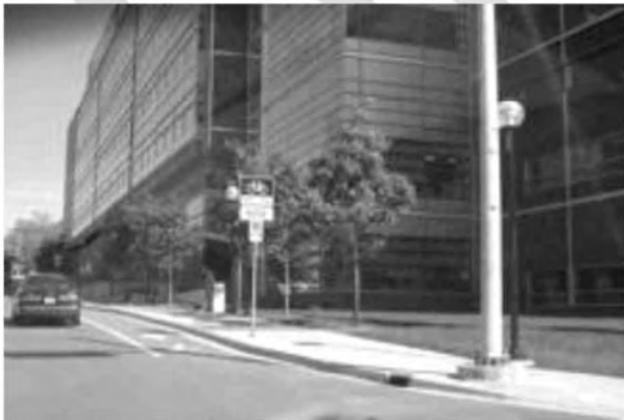
Caption: Exemplary signage and pavement marking

- This is an exemplary bike lane, constructed by the University of Michigan. Photos are from a previous year.
